ITX: TOOLCRIB DIAGNOSTIC SOFTWARE

STARTING TOOLCRIB

ToolCrib, which is installed with ITX software, is the main utility program for troubleshooting the ITX system.

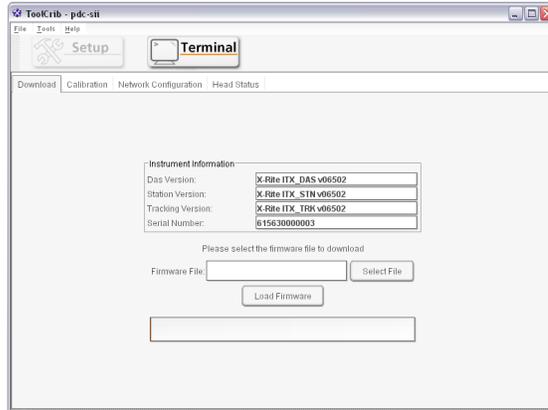
DOWNLOAD TAB

Instrument Information

Das Version - The firmware version of the DAS board in the head.

Station Version - The firmware version of the Station board (Also called the Rabbit Board). The Rabbit board is the same board that has the network connector.

Tracking Version - The firmware version of the Tacking board (Also known as the NCIS circuit board).

Serial Number - The serial number of the Station board. This is NOT the serial number of the track or head.

Firmware Loader

Firmware File - The name of the firmware file you selected to load into the system.

Select File - Used to select and browse for the firmware file you want to load into the system.

Load Firmware - Click this button to start the firmware loading process.

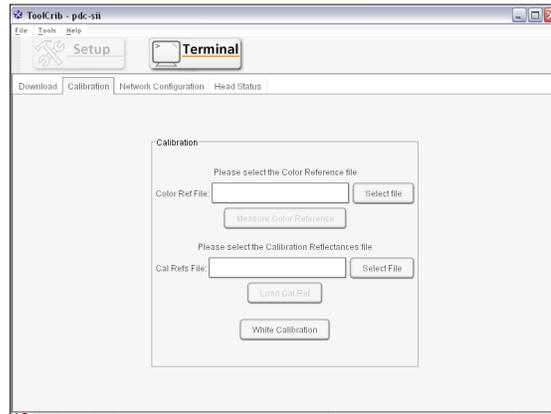
CALIBRATION TAB

Calibration Information

Color Reference File - Where you can load the values for the color reference card.

Calibration References File - Where you can load the values for the calibration reference plaque.

White Calibration - Will force the instrument to perform a full calibration.

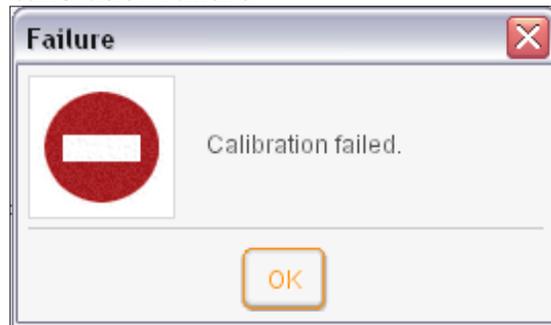
Calibration Failure

Possible Cause	Possible Solution
No calibration plaque in track.	Install the calibration plaque into the track.
Calibration plaque damaged.	Install a new calibration plaque.
Head is damaged.	The head will need to be serviced.

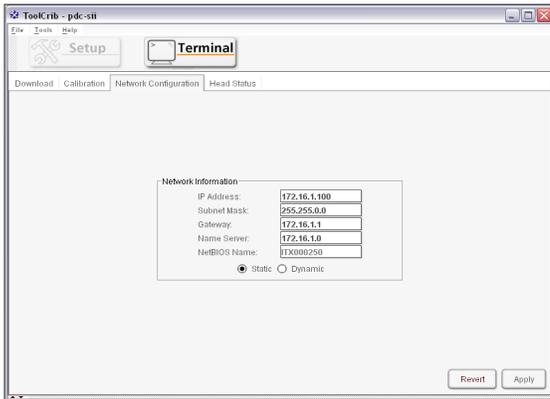
NETWORK CONFIGURATION TAB

Network Information

IP Address - Where you change the IP address of the system to a different static address.

Subnet Mask - Where you change the Subnet Mask to communicate with your network.

Gateway - This is where you change the Gateway to communicate with your network.

Name Server - Where you change the Name Server to communicate with your network.

NetBIOS Name - The name of the ITX track. This cannot be changed.

Static - Where you switch the system to a Static connection using a cross-over network cable.

Dynamic - Where you switch the system to Dynamic (DHCP) connection using a standard LAN network cable.

Revert - Click on this button to revert back to the prior settings before any changes were made.

Apply - Click on this button to lock the changes into the system.

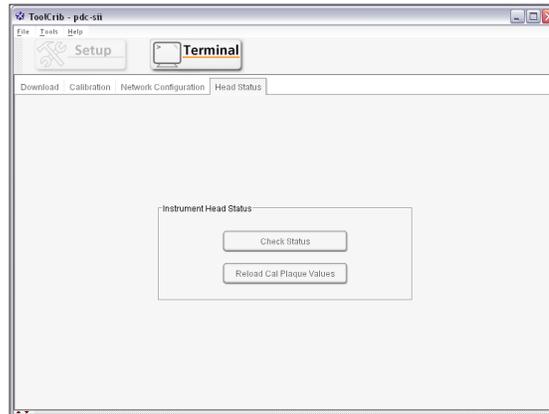
HEAD STATUS TAB

Instrument Head Status

Check Status - Click this button to go through the 'Head Swap' procedure.

Reload Cal Plaque Values - Where you change the Subnet Mask to communicate with your network.

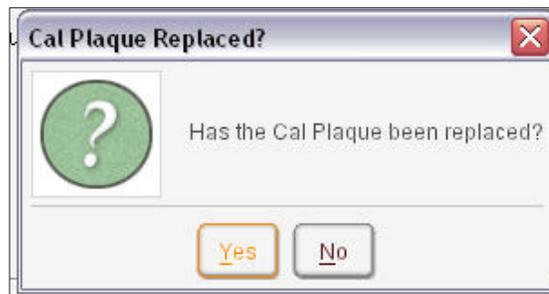
2. Change the calibration plaque in the track to match the one shipped with the replacement head. Click **Yes**.

If you hit **No** on ITX version 1.3.0.94 or higher it will give you an error message.

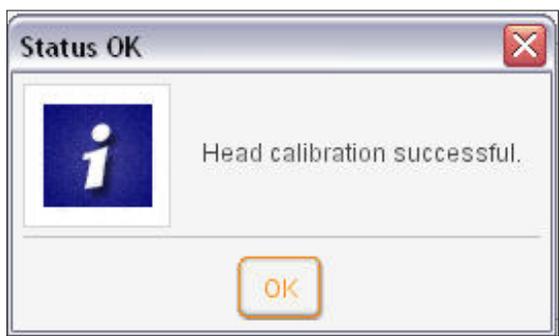
4. Once the Paper Stop (NCIS Sensor) calibration is complete it will do a full white calibration.

5. Click **OK** and close out of ToolCrib and launch the PressTool.

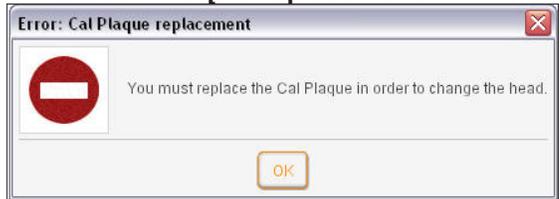
Calibration Plaque Replacement

Possible Cause	Possible Solution
Install the calibration plaque into the track. If you hit No the on ITX version 1.3.0.94 or higher it will give you this error message.	Change the calibration plaque in the track to match the one shipped with the replacement head.

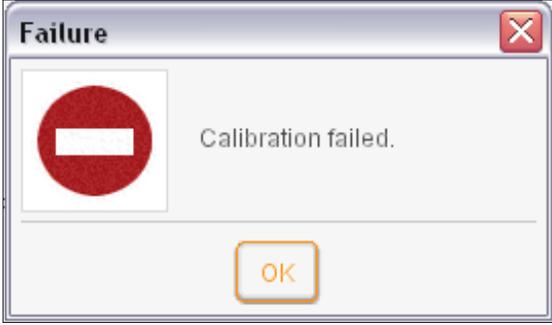
Calibration Failure

Possible Cause	Possible Solution
No calibration plaque in track.	Install the calibration plaque into the track.
Calibration plaque damaged.	Install a new plaque standard.
Head is damaged	The head will need to be serviced.
